U.S. Sugar - Diesel and Sheen Recovery

Clewiston, FL - April 2006

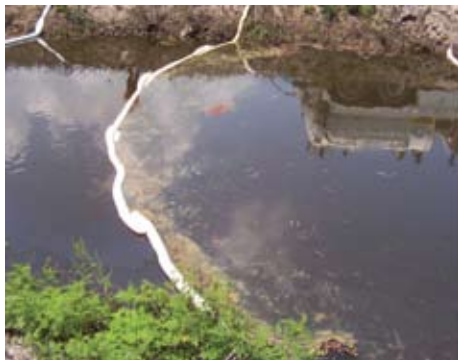
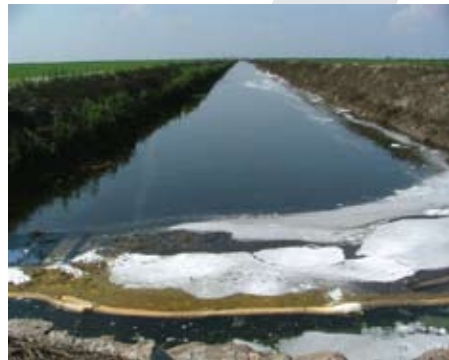
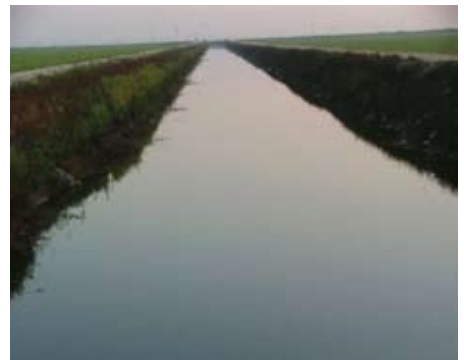
As a result of vandalism, diesel fuel was left spilling into a waterway. C.I.Agent® Quick Deployment Boom was placed between the irrigation pump wall and ACT Environmental Company boom material. Approximately 30 to 50 pounds of C.I.Agent® Granules were applied to an area of 100,000 square feet of sheen. Another five pounds of product was applied to several small pockets of diesel fuel trapped by a man-made containment device.

Sheen continued to come from the area around the intake of the pumping station. Diesel fuel had saturated parts of the ground where the hose from the 500 gallon storage tank had been vandalized.

Workers proceeded down the canal approximately one half mile to the area where most of the product remained. The product was contained by the retaining wall of the canal on three sides and ACT had a boom in place on the fourth side.

All waste was gathered and put into 55 drums: 3 drums of ACT five inch booms, one to two drums of weeds, debris, approximately 15 gallons of solidified diesel fuel, and C.I.Agent® materials. A 100 foot C.I.Agent® Quick Deployment Boom was placed to gather any remaining sheen.
